NEW MEXICO ENVIRONMENT DEPARTMENT

Re: Gallardo Construction, LLC / Metro Verde South 3C; CGP; SIC 1521; NPDES Compliance Evaluation Inspection; NPDES #NMR100016Q; May 3, 2018

NPDES Compliance Inspection Report

NPDES Construction General Permit Inspection Report – State of New Mexico

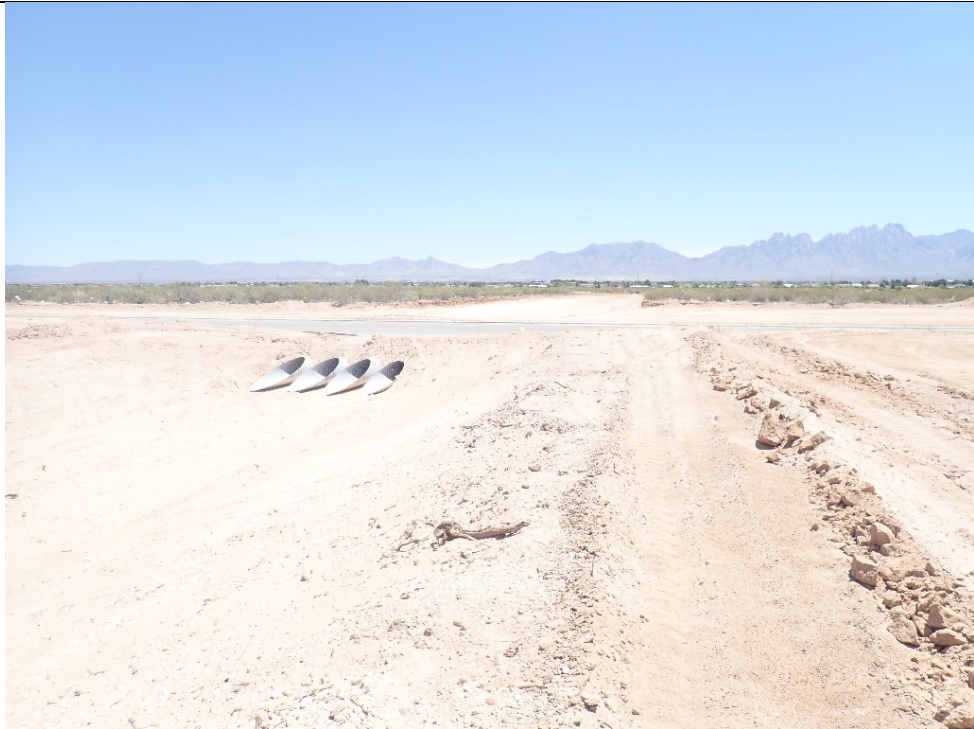
NMED/SWQB Official Photograph Log Photo # 4		
Photographer: Jennifer Foote	Date: 5/3/18	Time: 11:32 am
City/County: Las Cruces/ Dona Ana		State: New Mexico
Location: Metro Verde		
Subject: discharge channel no stabilization

- Part 2.2.14 No documentation of method of stabilization of disturbed areas. Response: Clarified in para. 10.2 of the SWPP.
- Part 2.3.1.f Vehicle leaking oil. Response: Cleaned up later that day by Gallardo Const.: See Appendix A of the NMR1000UH inspection attached.
